AIRCRAFT ACCIDENT INVESTIGATION REPORT

Crash Accident of Mi-8, P-313, Air Koryo
On 9 July, 2005
In Chonnamri, Hyongjesan District, Pyongyang

**Aircraft Accident Investigation Committee,
General Administration of Civil Aviation,
Democratic People's Republic of Korea**

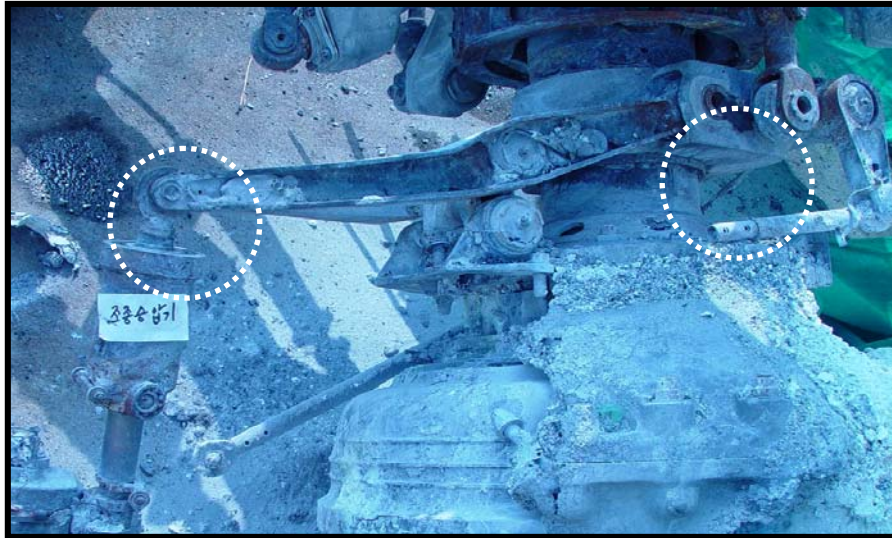
Figure 1 Positions of automatic slope controller sliding plate and booster

During the investigation, it was confirmed that sliding axle plate of automatic slope controller was in maximum limit and its booster piston rod being in maximum position (47mm).

It shows that the crew pulled pitch-throttle control lever to the maximum.

As a result, the helicopter had a nearly vertical descent and the main rotor disc collided with the top side of the heap of wood. The main rotor blade No5 was broken and thrown into the guardhouse roof due to heavy impact and rotating moment and other blades (No 4,3,2,1) sequentially collided in rotation direction, being broken out or bent.

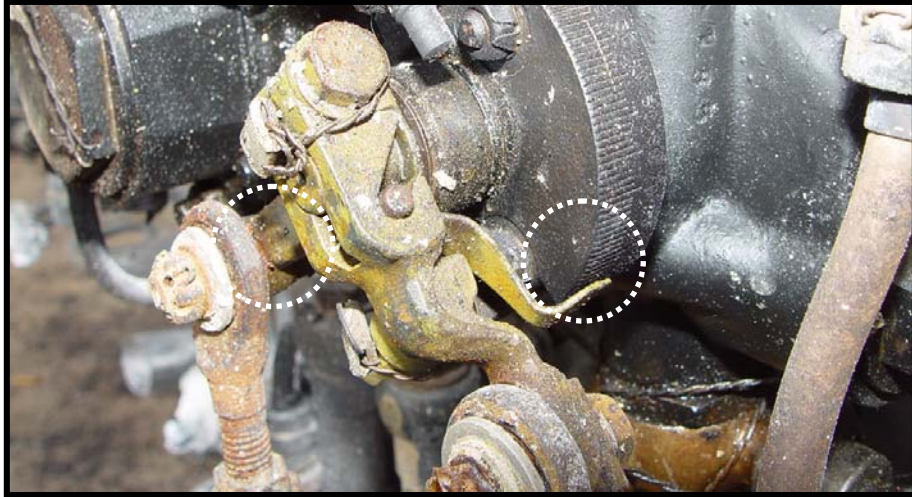
Figure 2 Positions of rotation lever of engine high pressure fuel pump and cut-off valve

During the investigation, it was confirmed that the cut-off valve of the left engine was in open, which seems that the crew have tried engine restarting.
